Acoustic Nondestructive Testing And Measurement of Tension for Steel Reinforcing Members

Part 2 - Field Testing

by Michael K. McInerney

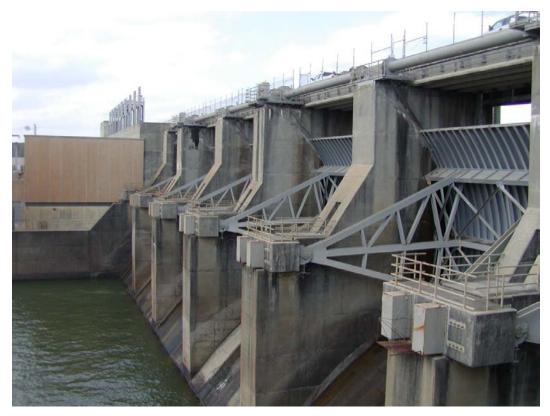
Figure 2. Typical tainter gates and trunnions.

Figure 2 is a photograph of tainter gates and trunnions at one of the test locations. In this picture, the anchor rods are located behind the pairs of vertical rectangular steel enclosures about halfway up from the water line.

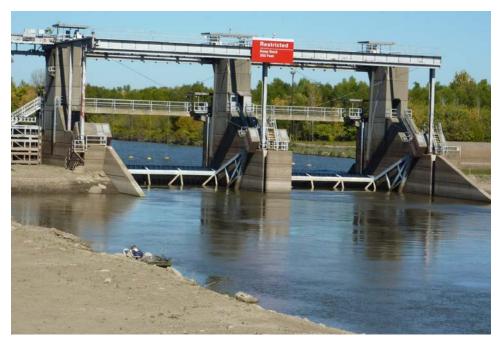
Figure 7. Site of third field test, Kaskaskia Lock and Dam, Illinois.

The third field test was conducted at Kaskaskia Lock and Dam in Illinois (Figure 7). Rod ends are shown in Figure 8. Of the 112 rods in the sample, 42 measured 42 ft long, 42 were 46 ft, and 28 were 50 ft. All rods were 1.25 in. diameter, and the filler material was grout.
